TEST REPORT

Report No.: E7778.01-301-16

SOLATUBE INTERNATIONAL, INC.
VISTA, CALIFORNIA

PRODUCT TYPE: Tubular Daylight Device – Self Flashing
SERIES/MODEL: 330DS/750DS

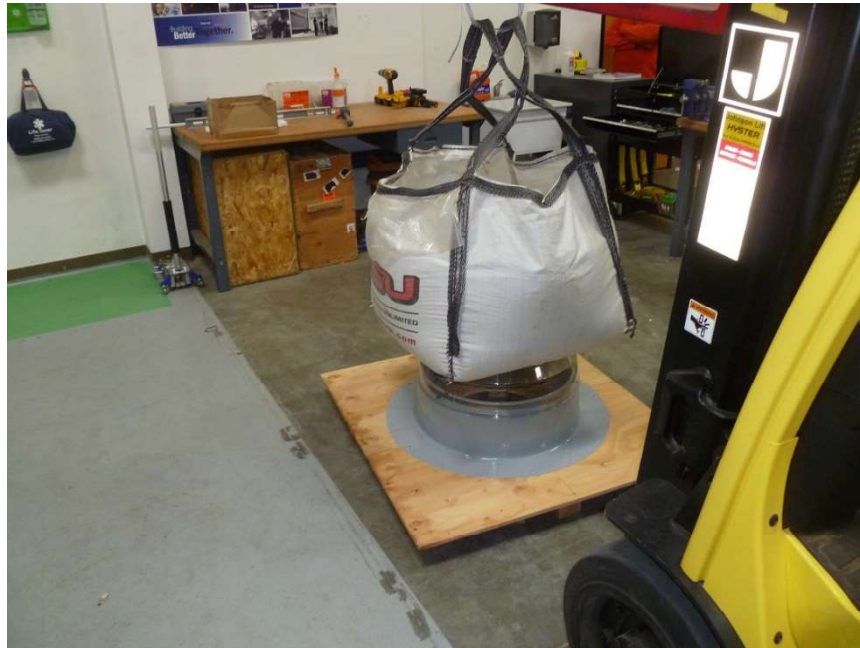
Photo No. 1
750 DS TDD during static loading

A 700 lbf weight, fabricated from a bag filled with sand, was placed on the center of each dome for a minimum of 60 seconds. The bag was removed and the test unit was inspected for any signs of damage or failure.

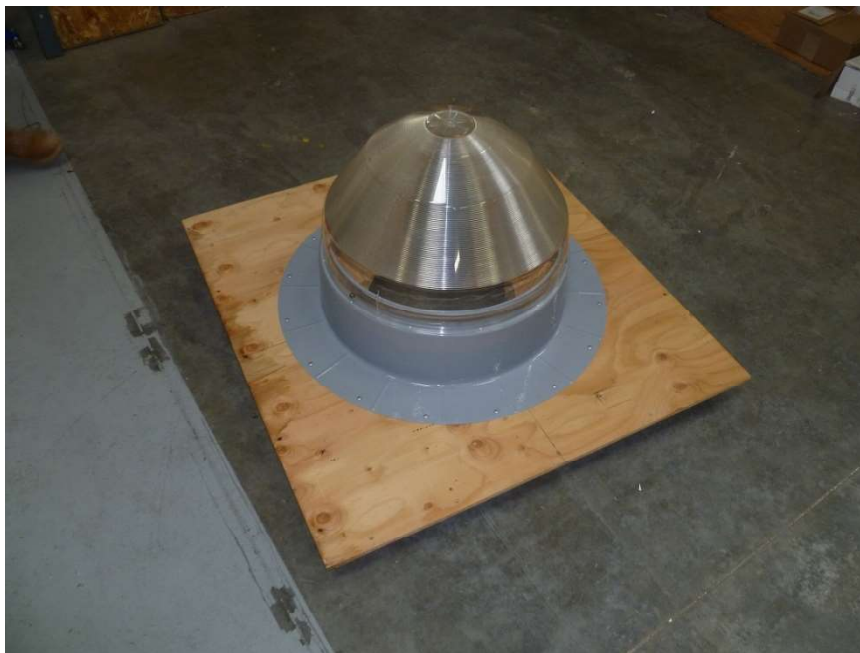
Photo No. 2
750 DS TDD after static loading

Note: The 700 lbf weight was gently applied perpendicular to the center of each dome. After 60 seconds of rest time, there was no visible damage to either skylight.

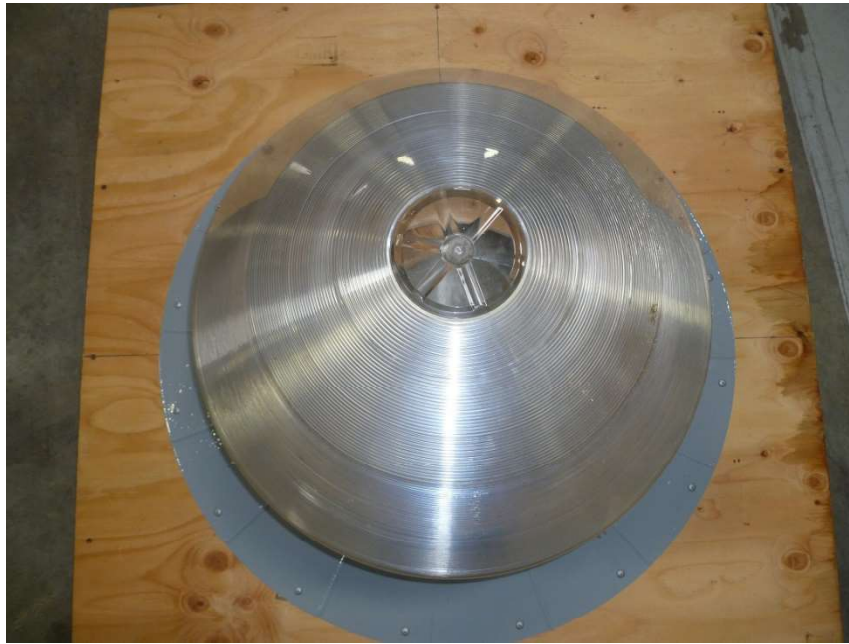
Photo No. 3
750 DS TDD after static loading

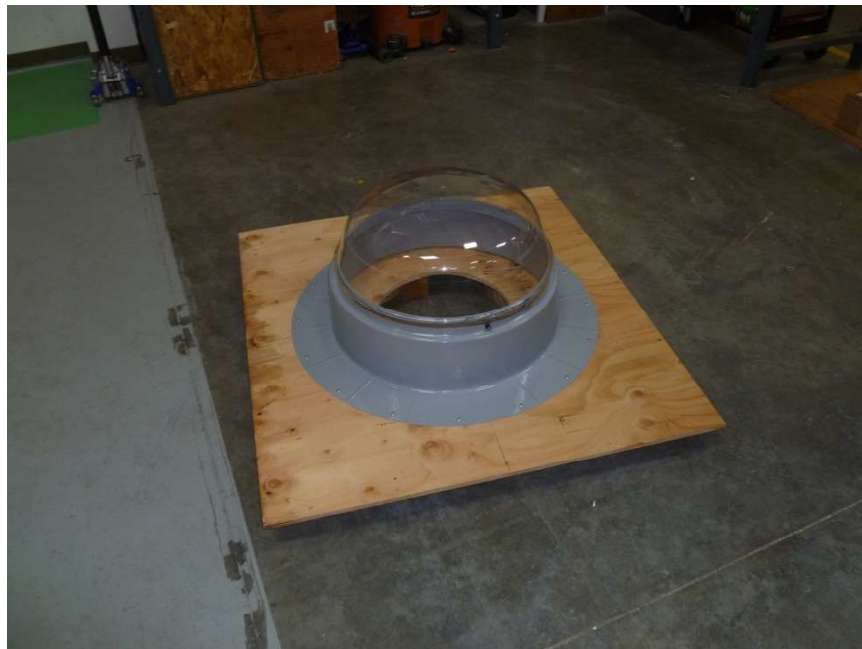
Photo No. 4
330 DS TDD after static loading

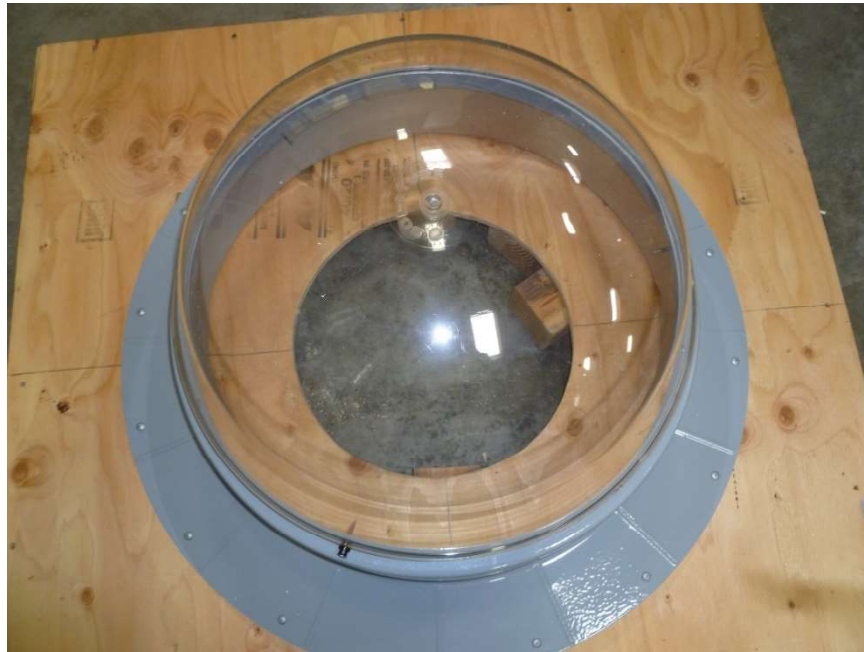
Photo No. 5
330 DS TDD after static loading
