## **TEST REPORT**

Report No.: C5760.04-301-44

SOLATUBE INTERNATIONAL, INC. Vista, California

**PRODUCT TYPE**: Tubular Daylight Device – Open Ceiling **SERIES/MODEL**: M74 DS

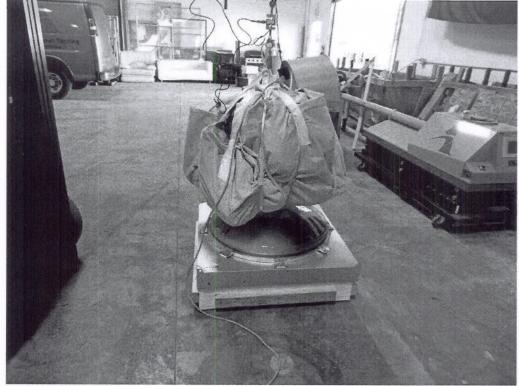
Photo No. 1: Weight of bag prior to drop test (700 lbf)

A 700 lbf weight, fabricated from a bag filled with sand, was placed on the center of the dome for a minimum of 60 seconds. The bag was removed and the test unit was inspected for any signs of damage or failure. The bag was then dropped from a 2' height above the dome, any visible damage was noted.

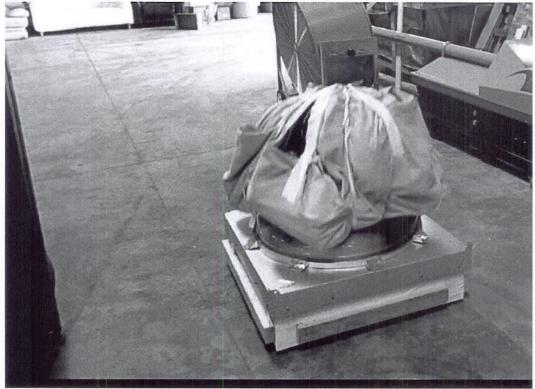
Photo No. 3: After impact of the 700 lbf static load from 2 foot drop height

Test Method	Load Location	Results	
700 lbf-ft. (2' drop height)	Center of dome	No visible damage
